TECHNICAL REPORT

NO. 12776

WINTER TESTING OF VEHICLE
EXHAUST DUST EJECTION SYSTEM, RUBBER
TIRE HUBS, AND PERSONNEL HEATER SYSTEM
ON THE M60 A3 TANK

JUNE 1982

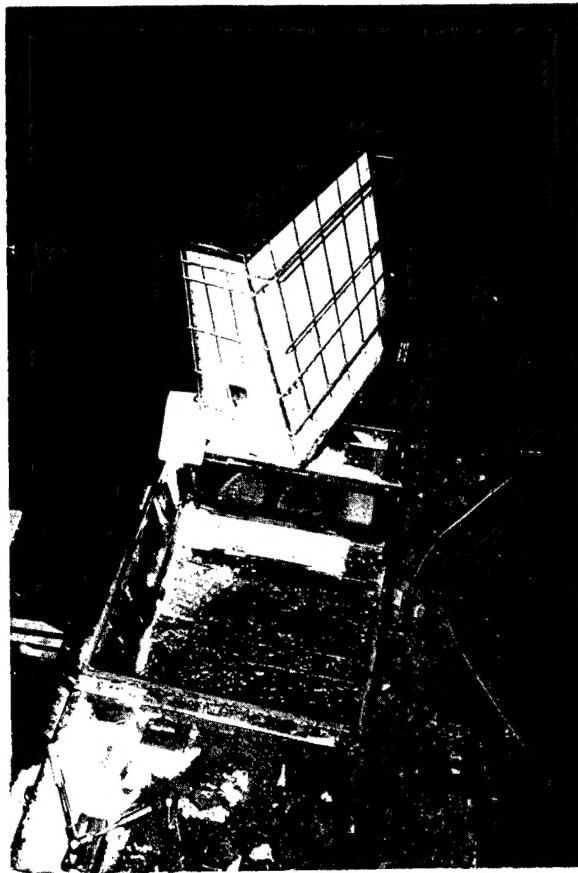
Both the VEDES and ACBM air filter elements would clog up with snow when the vehicle was operated in freshly fallen or powder (very light and dry) snow. The VEDES filter element did clog up fast, however. Figure 1 shows the VEDES filter compartment after 5 miles of driving in a heavy snow storm. The restriction indicator reached 30 inches of water.

Figure 1. VEDES filter element and filter compartment after 5 miles of driving in a heavy snow storm.

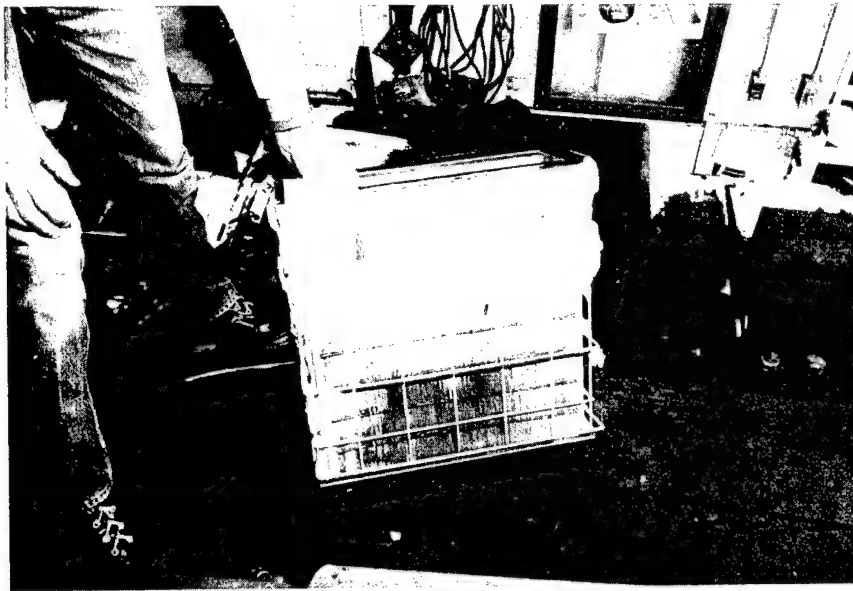
1. A heavy layer of snow had accumulated on the VEDES filter element. The snow covered approximately 75% of the filter media on both sides of the filter element. Figure 2 shows the filter element covered with snow.

Figure 2. VEDES filter element after 50 miles of operation in powder snow.

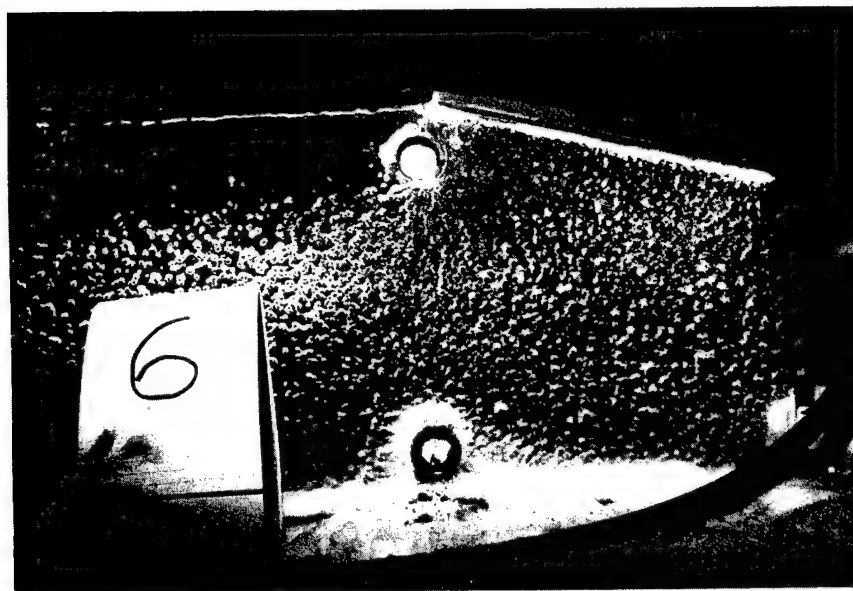
2. Snow had accumulated in the pre-cleaner and had reached the top of the scavenge cleanout plug. See Figure 3.
3. Restriction on the VEDES filter element had reached 20 inches of water. See Figure 4.
4. The VEDES check valve was found to be frozen shut as a result of water accumulation and freezing in the scavenge tube.
5. A layer of snow covering approximately 25% of the ACBM filter element was found. See Figures 5 and 6.
6. Restriction on the ACBM filter element had reached 4.8 inches of water.
7. There was no accumulation of snow in the pre-cleaner compartment of the ACBM system.

Figure 3. Snow accumulation in the pre-cleaner after 50 miles of operation in powder snow reached the top of the scavenger cleanout plug.

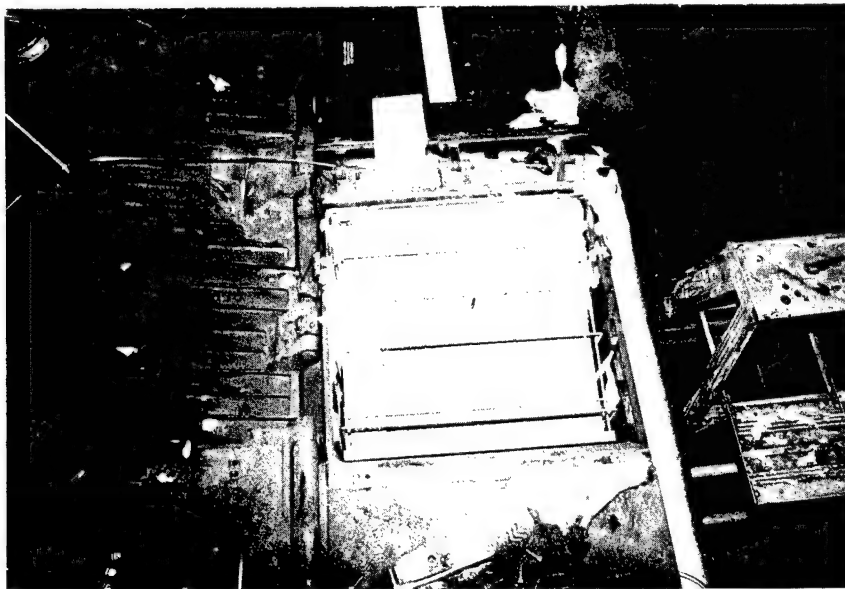
Figure 5. ACBM filter element after 50 miles of operation in powder snow.

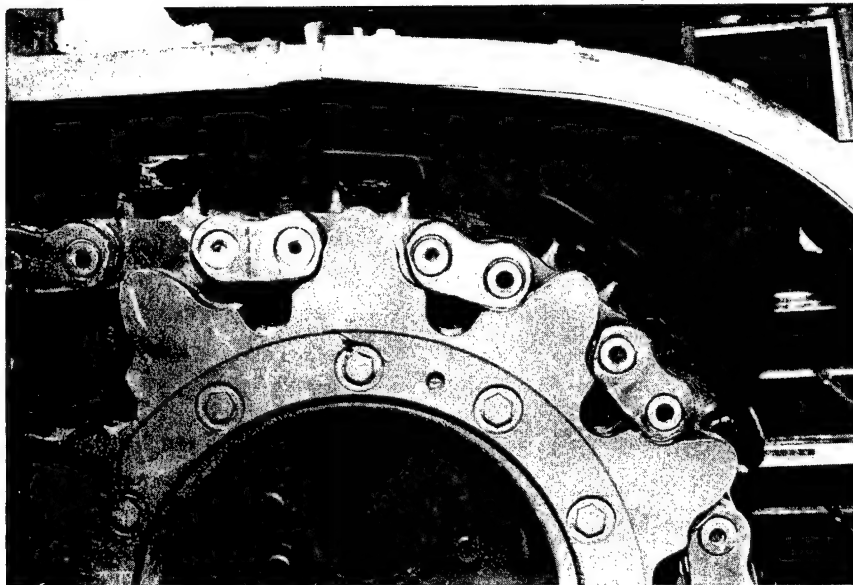
it was noted that there was a mismatch between the RTH sprockets and the track end connectors. This mismatch caused wear to the sprocket teeth and end connectors as seen in Appendix A. Appendix A shows wear to three selected end connectors on both sides of the track as well as the wear to the RTH sprockets.

One set of tracks was worn out after 250 miles of operation. The track was replaced with a spare, and end connector and sprocket wear were recorded. Figure 12 shows the excessive wear between the sprocket teeth and end connectors after 250 miles.

Figure 12. Track and sprocket misalignment and excessive end connector wear (250 miles).

1. The Rubber Tire Hubs were improperly installed or were too thick, causing the sprocket and track to misalign.
2. Snow can buildup between the RTH sprocket and track, causing the track to climb over the top of the teeth.
3. RTH needs further development and testing.

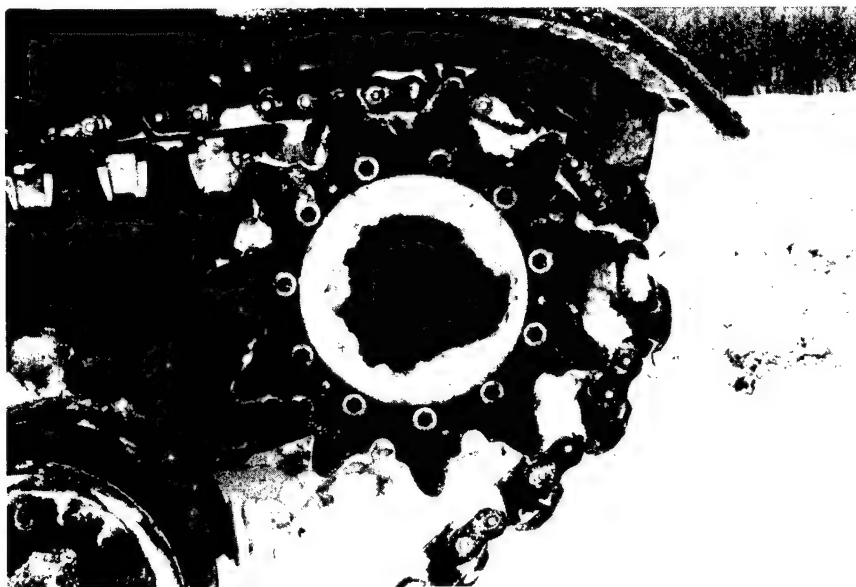
Snow was definitely a problem for the rubber tire hubs. The hubs would pack with snow and cause the track to jump over the drive sprocket teeth. The driver had to be careful not to jump the track.

Figure 13 shows the track climbing over the top of the sprocket teeth. Figures 14 and 15 show the snow build-up between the RTH and the track causing the track to lift up and misalign. Figure 16 shows the test vehicle operating in a typical snow environment.

Figure 13. Snow build-up between the track and sprocket caused the track to climb over the sprocket teeth.

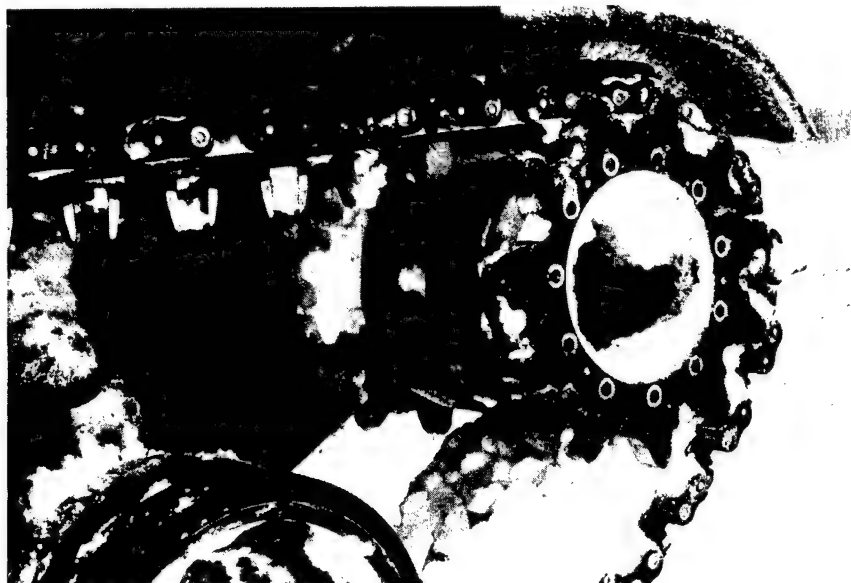
Figure 15. Snow build-up between the track and sprocket.
